MONTEREY, TENN.  
N 3607.5—W 8515/7.5  
1955  
PHOTO REVIEWED 1980

## LANDSLIDES AND RELATED FEATURES

OF THE MONTEREY, TENN. QUADRANGLE  
by  
Roger E. Thomas and Alfred R. Taylor

U.S. Geological Survey  
OPEN FILE MAP 82-653(B-6)

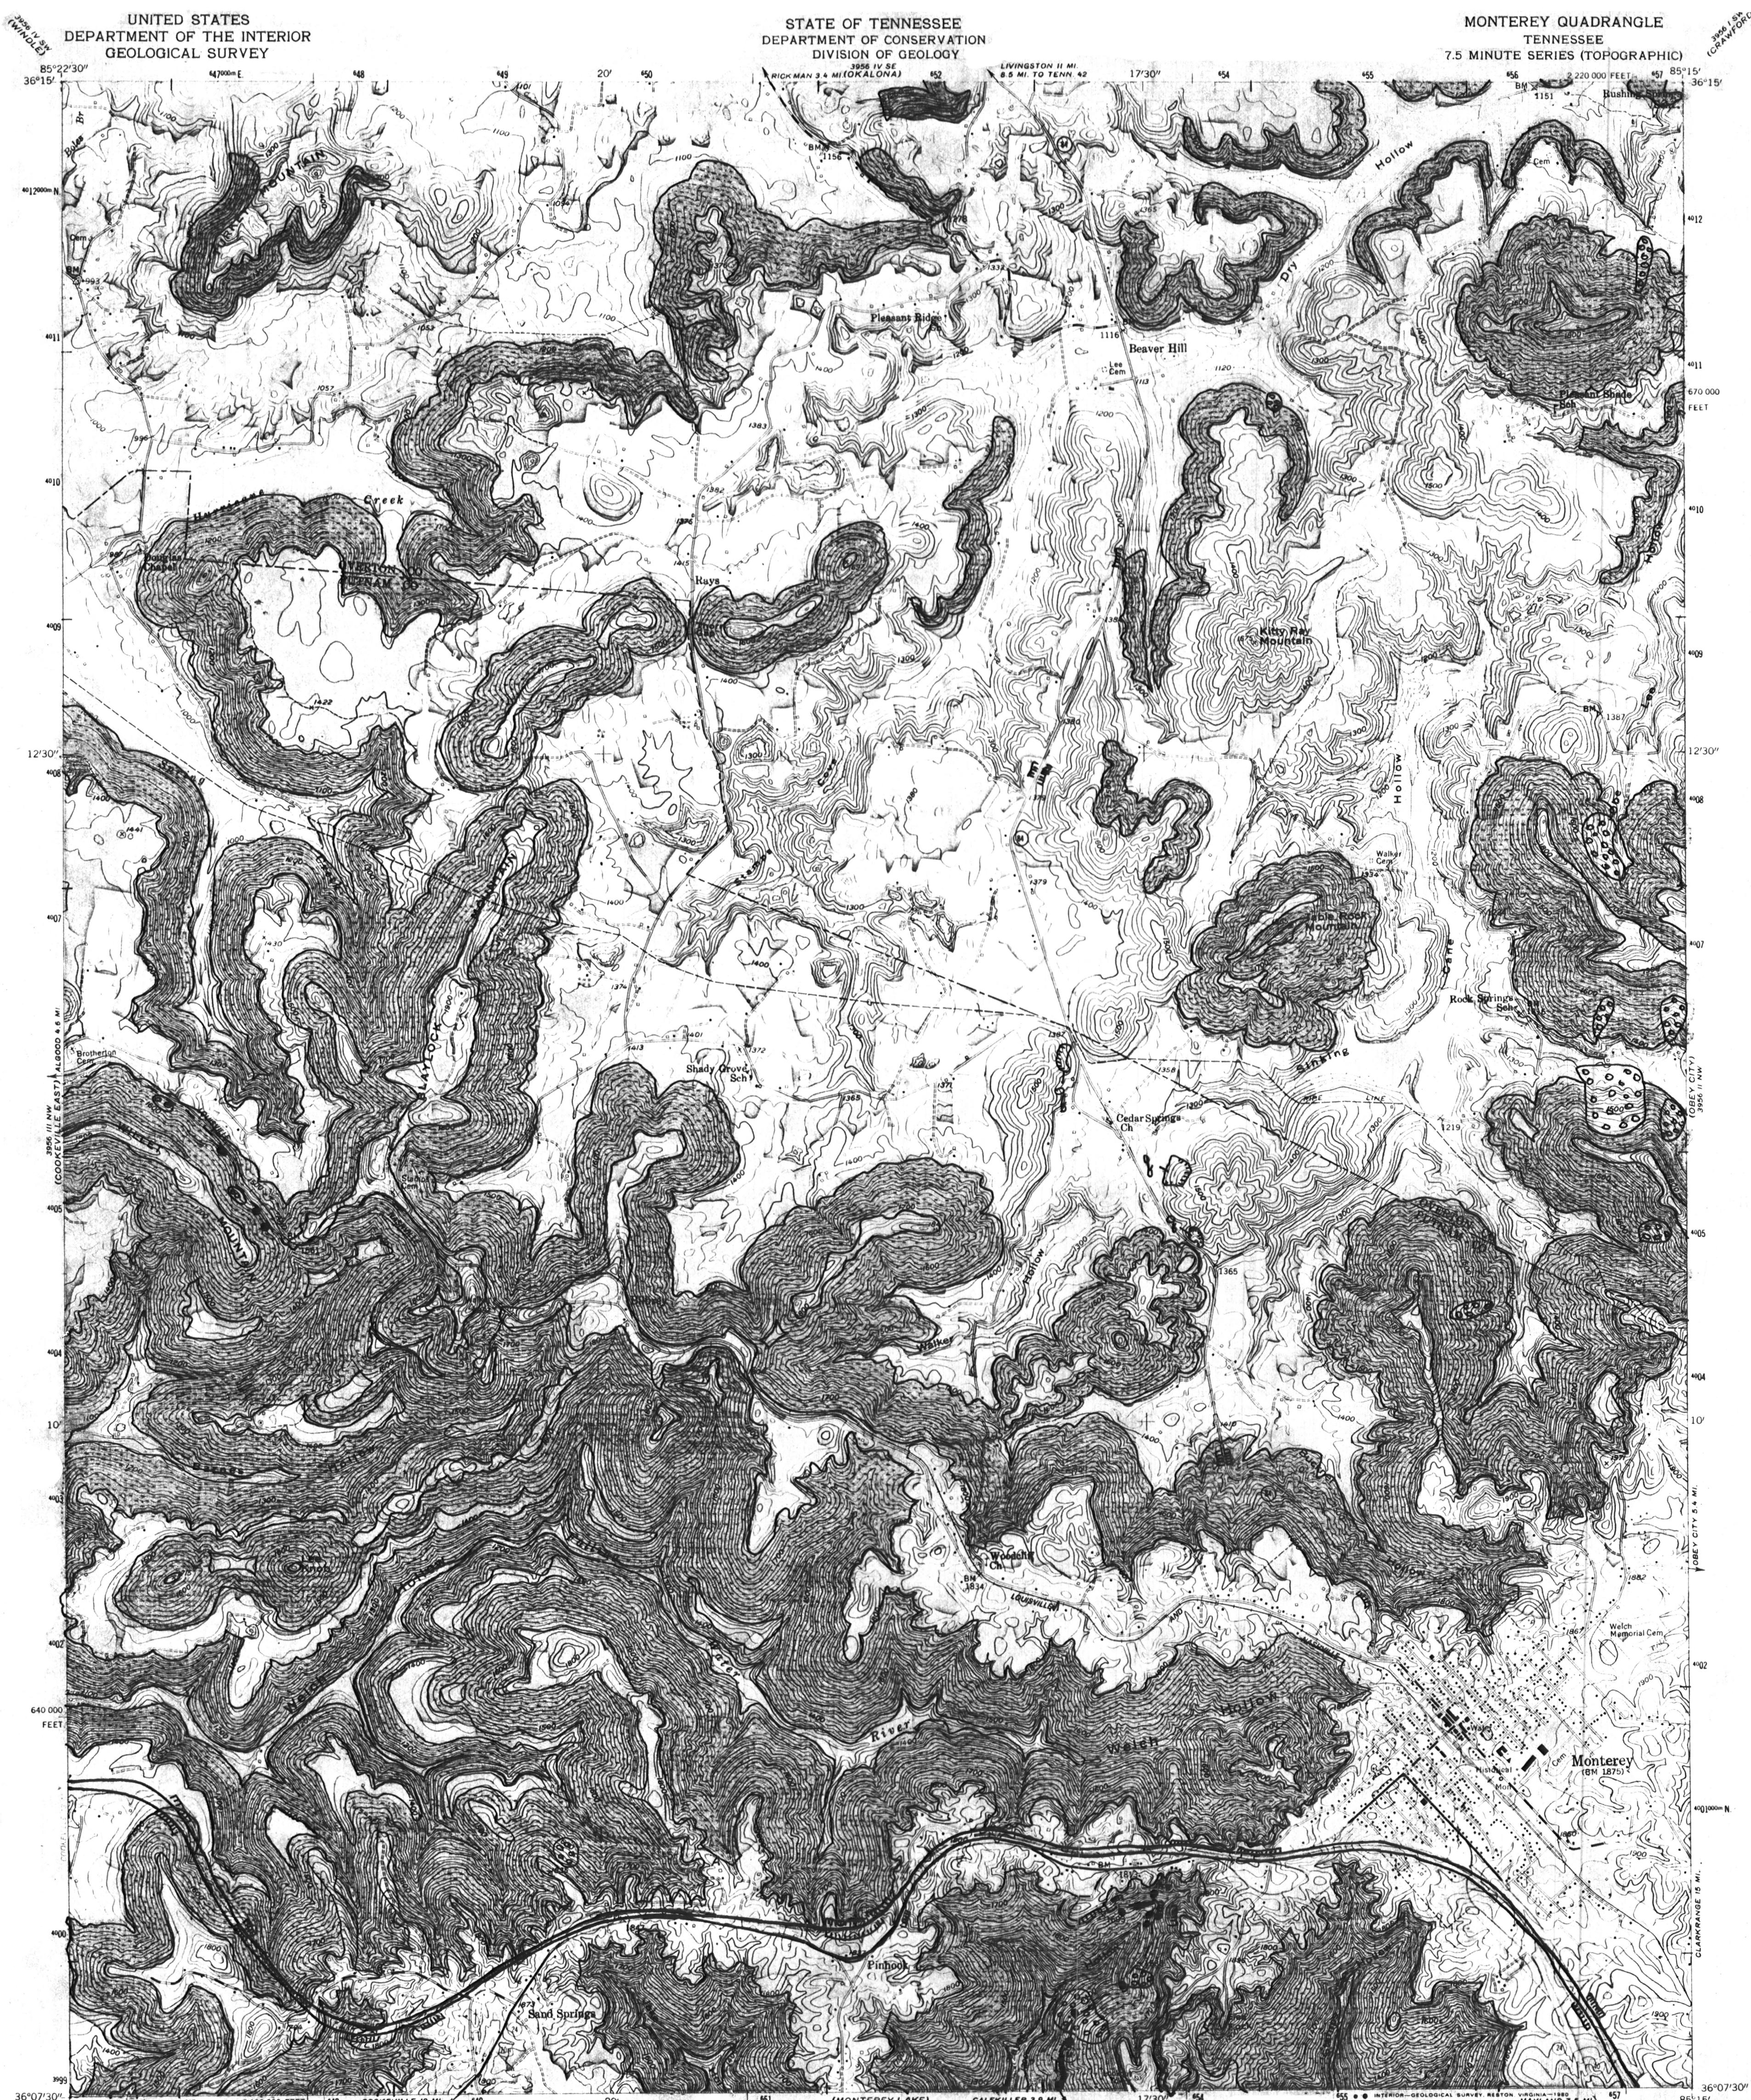
Landslides and related features interpreted  
from aerial photographs:  
1:40,000 (Black and White) 1978  
1:80,000 (Black and White) 1976

Photointerpretation and field check 1979-1980  
This report is preliminary and has not  
been reviewed for conformity with U.S.  
Geological Survey editorial standards.

**ACTIVE OR RECENTLY ACTIVE LANDSLIDE**  
Complex landslide composed of earthflow, debris  
slide, earth and rock slump. Identified from  
historical records, and from scars, debris and  
other field evidence. Ground extremely unstable;  
sliding accelerated by excavation, loading and  
changes in drainage conditions. May include  
areas with several active slides too small to  
be shown separately. Questioned where doubtful.

**OLD LANDSLIDE**  
Area of extensive hummocky ground caused by  
earthflow and earth and rock slump. Lacks  
clear evidence of active sliding. Relatively  
stable in natural, undisturbed state,  
generally not affected by small structures properly  
sited in areas away from the edge of the toe;  
can be reactivated by extensive, rapid exca-  
vation, loading, and changes in ground water and  
surface water conditions. Area of old landslide  
probably includes recent ones not identified  
from field evidence or otherwise documented.  
Upslope boundary of landslide generally defined  
by modified scarp, but downslope (toe) may be  
gradational and not well defined. Questioned  
where doubtful.

**COLLUVIAL SLOPE**  
Valley wall along major streams with slope as  
steep as 40° (85%); stony, clayey silt soil up  
to 50 ft. (15 m) thick; commonly buttressed by  
a terrace or bench at the toe of the slope; very  
susceptible to sliding by cutting of toe area,  
removal of terrace or bench, and overloading;  
slide commonly activated without apparent cause.

**AREAS SUSCEPTIBLE TO DEBRIS FLOWS AND DEBRIS  
AVALANCHES**  
Primarily shallow, narrow ravines and chutes with  
accumulation of stony colluvium generally 10 ft.  
(3 m) or less in thickness; susceptible to rapid  
movement during intense rainfall. Most ravines  
and chutes designated show evidence of former  
debris flows and avalanches.

**AREAS SUSCEPTIBLE TO ROCKFALL**  
Steep, locally vertical, natural and man-made  
slopes and cliffs, 15 ft. (4.5 m) or more high;  
formed dominantly of sandstone, limestone, sandy  
shale, mudstone and claystone. Interbedded mud-  
stone, claystone and shale weather rapidly leaving  
sandstone and limestone rock faces unsupported.

**SOIL AND ROCK SUSCEPTIBLE TO LANDSLIDING**  
Soil and rock similar to that involved in land-  
slides elsewhere in map area; primarily areas  
underlain by claystone, mudstone and shale  
associated with other rock types. Rock weathers  
rapidly on exposure forming clayey soil highly  
susceptible to sliding. Includes coves (U-shaped,  
shallow valleys) containing thick layers of clayey  
soil that are very susceptible to sliding where  
excavation breaks continuity of slope and where  
overloaded by artificial fill.

**NOTE**  
Information shown is intended as a  
general guide to ground conditions as of  
the date of field check. Additional  
landslides and rockfalls should be anticipated  
in all map units. The map unit depicts  
the dominant condition in the area delineated  
and variations in slope stability may occur  
at any point in the unit. This map is suit-  
able for general planning purposes and as a  
supplement to more detailed studies for site  
selection. The map cannot be used as a sub-  
stitute for detailed geologic and engineering  
investigations to establish design and  
construction criteria of specific sites.  
Some symbols may not appear on this map  
because the description is applicable to a  
series of maps.

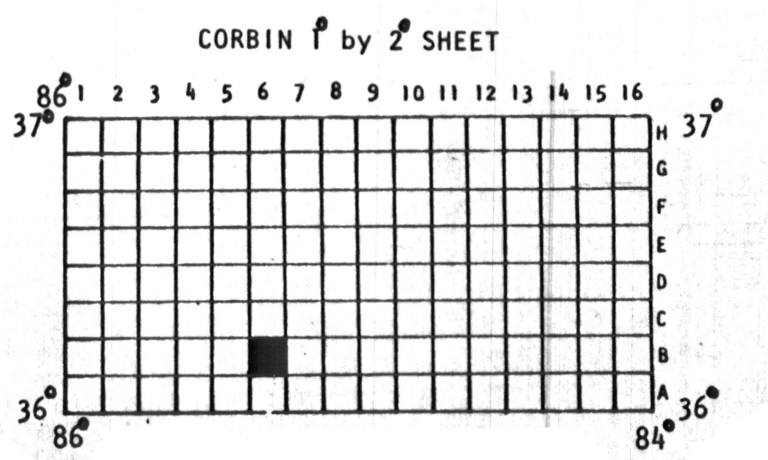
The first five digits of the open file number designate the  
specific 1:250,000 scale map sheet of which this quadrangle  
is a part. The last two digits designate the position of the  
quadrangle in a subdivision of the 1:250,000 scale map based  
on rows and tiers shown in the diagram to the right. The  
location of this quadrangle is shown by the black square.
